WADC TECHNICAL REPORT 55-234

FABRICATION AND TEST OF TITANIUM JET PODS

CONVAIR
A DIVISION OF GENERAL DYNAMICS CORPORATION
(FORT WORTH)

**AIRCRAFT LABORATORY
CHANGE ORDER 105 TO CONTRACT NO. AF33(038)-2182
PROJECT NO. 1368**

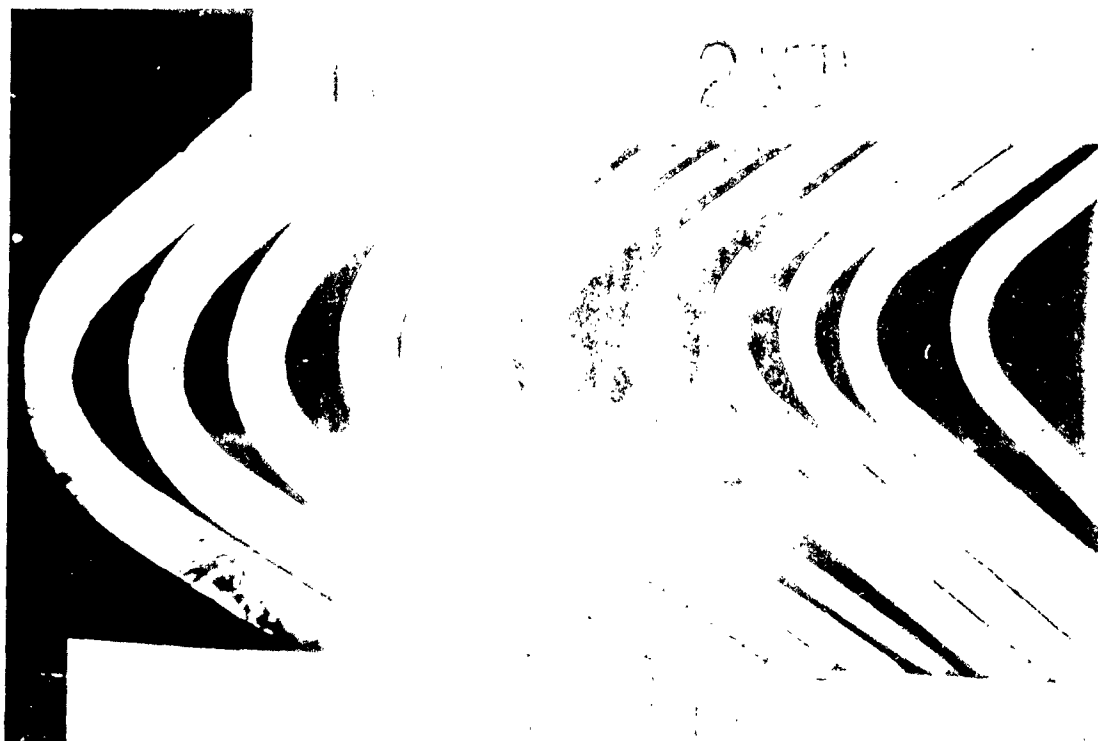
SAME COUPONS AS SHOWN IN FIGURE 1, BUT WITH TRACKS REMOVED BY MACHINING 1/16-INCH OFF THE EDGES.

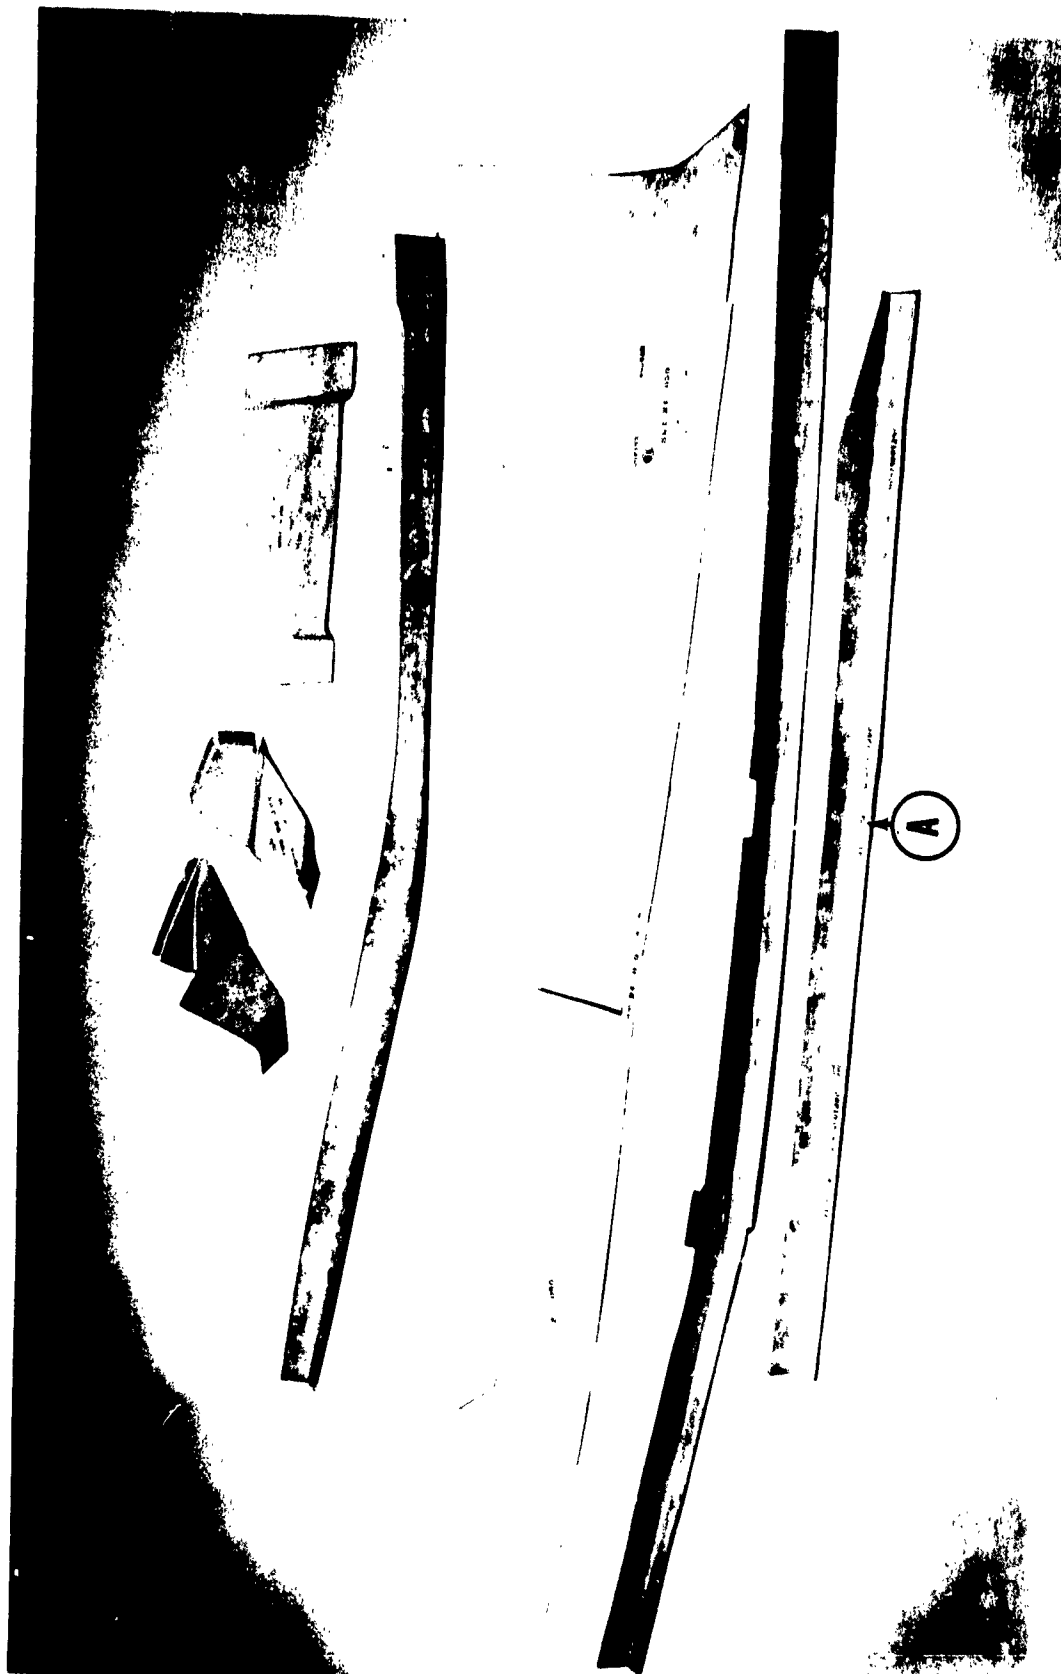
FIGURE 13

THESE DETAILS WERE DROP HAMMER FORMED FROM RS120 MATERIAL. THE LOWER ANGLE PART IS A VARIABLE ANGLE SECTION OF SLIGHT CONTOUR AND JOGGLE IN ONE LEG. TO CONSERVE MATERIAL, THIS PART WAS BRAKE FORMED TO A CLOSED DEGREE ANGLE, THEN SIZED ON A DROP HAMMER DIE, RESULTING IN SAVING IN TRAPPING MATERIAL NORMALLY REQUIRED IN DROP HAM-

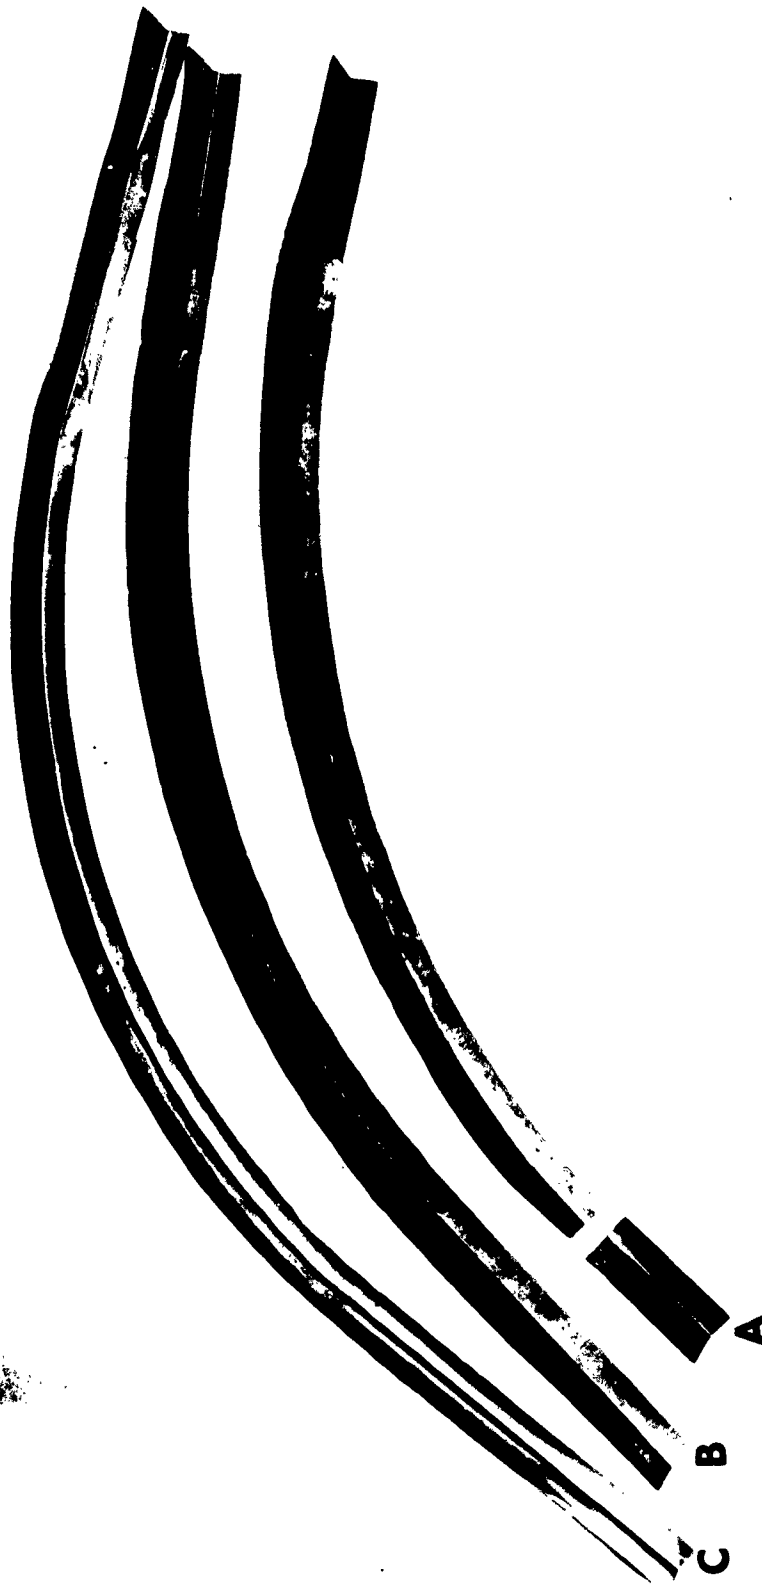
FIGURE 16

COMPARATIVE SPRINGBACK AND ELONGATION BETWEEN RS120 TITANIUM ALLOY AND ONE-FOURTH HARD STAINLESS STEEL ARE SHOWN ON THESE STRETCH-FORMED PARTS. THE CENTER PART IS RS120 TITANIUM ALLOY AND THE UPPER IS STAINLESS STEEL. THE STAINLESS STEEL PART IS OF THE CORRECT CONTOUR. ELEVATED TEMPERATURES DID NOT CORRECT THIS PROBLEM. PARTS "A" AND "B" ARE TITANIUM ALLOY; BOTH WERE BRAKE-FORMED AT 550°F AND COLD STRETCH FORMED.

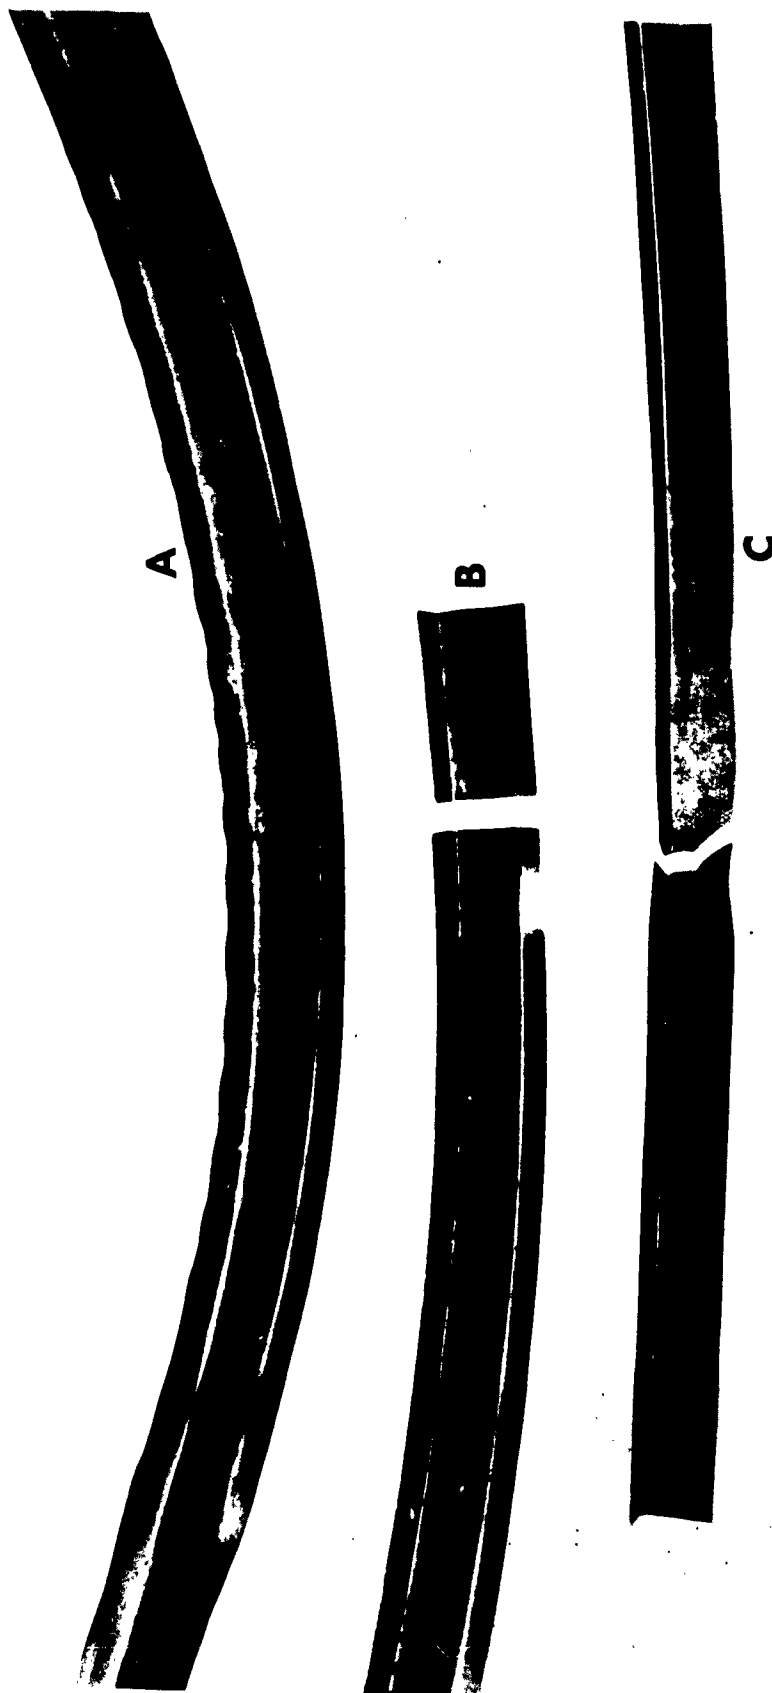
FIGURE 17

THE RESULT OF STRETCH FORM OPERATIONS ARE SHOWN IN THIS PHOTOGRAPH. THE TENDENCY TO NECK LOCALLY IS SHOWN BY THE LOWER PART WHICH WAS STRETCH FORMED AT 550°F. ELONGATION RESULTS FROM LOSS OF FLANGE HEIGHTS.

Localized necking or reduction in flange width was also encountered while no loss in gauge was experienced; loss in flange height in localized areas was noted. This was especially noticeable in sharp bend areas. In order to overcome this problem, excess material was added to the flange width. This excess was removed after forming.
(Reference Figure 17, page 55)

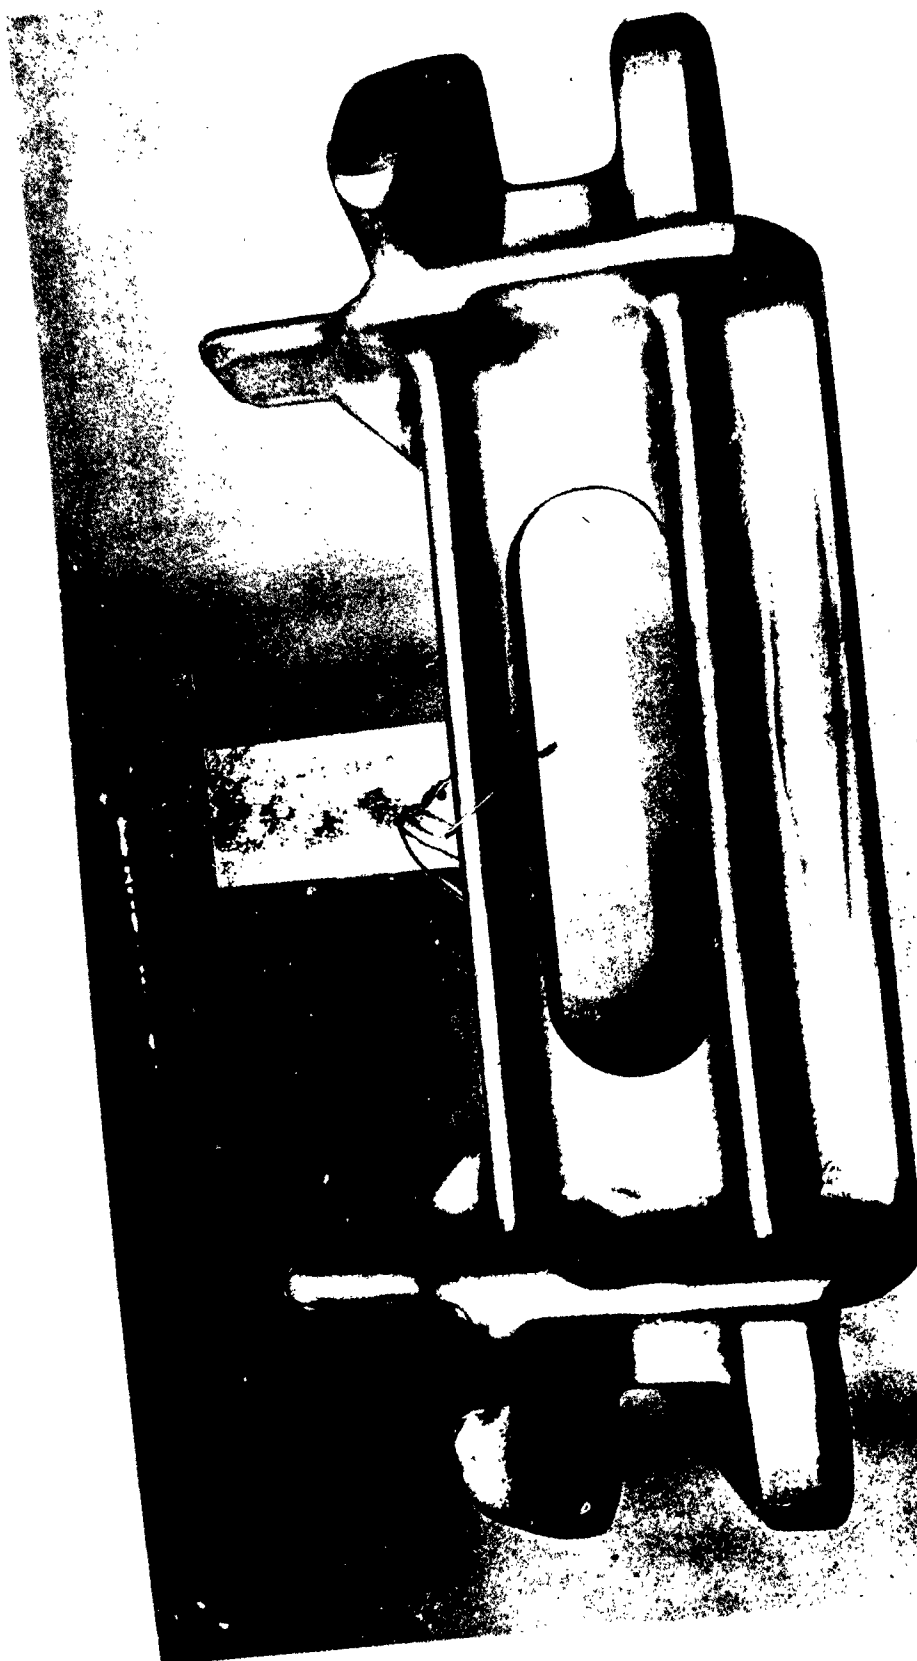
FIGURE 22
IMPERFECT FORGING SHOWING SHUTS AND UNFILLED AREAS.
